## JOINT FILLER SEPARATION; CAUSES, CORRECTION

T-5

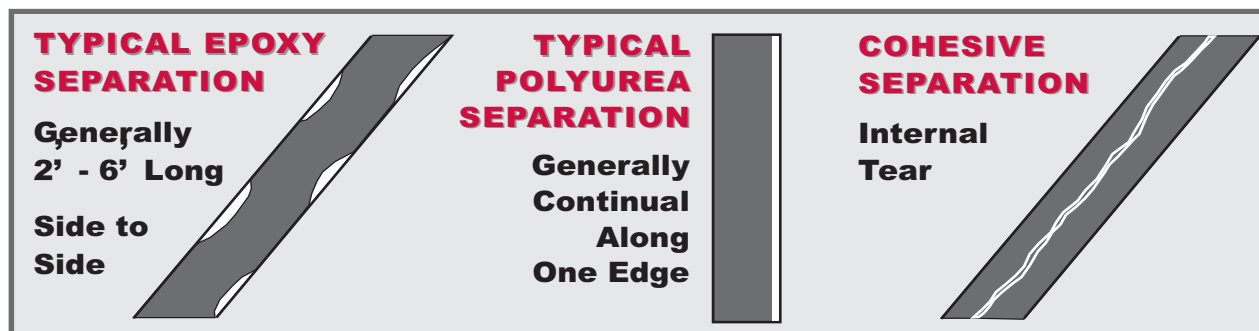
Semi-rigid fillers generally tend to separate adhesively (filler-to-concrete), although cohesive separation (within the filler) is not uncommon when joint preparation is above average. Epoxies generally separate in a "leap-frog" pattern (jumping back and forth across joint) while polyureas tend to separate continually along only one side.

**TYPICAL EPOXY SEPARATION**

Generally  
2' - 6' Long  
Side to  
Side

**TYPICAL POLYUREA SEPARATION**

Generally  
Continual  
Along  
One Edge

**COHESIVE SEPARATION**

Internal  
Tear

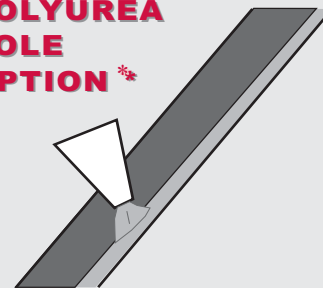
**POLYUREA SOLE OPTION \***

\* Polyureas, due to their chemical nature, cannot be easily saw-cut out. Thus filling separation void is the only viable option.

Use knife or narrow tool to loosen debris. Blow/vacuum clean. Fill (overfill) voids with Spal-Pro RS 88 Polyurea and allow to set into solid. Razor off flush.
