Wide Joint Spall Repair Using M/M's Armor-Hard

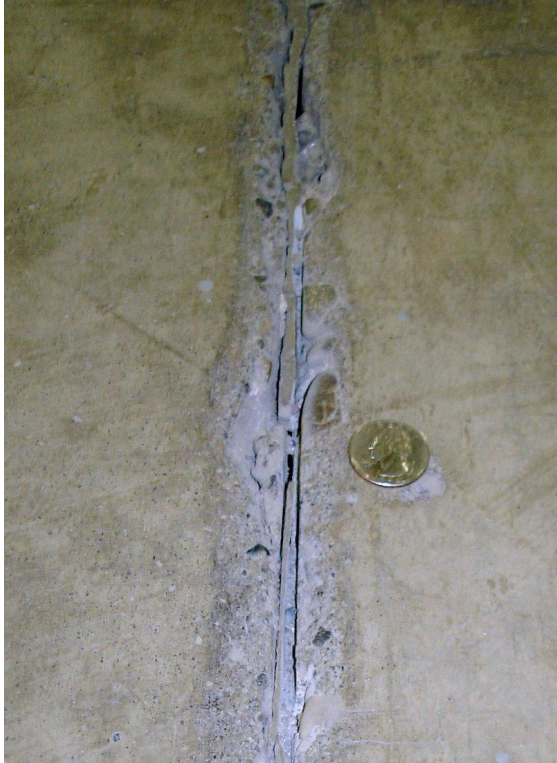
Existing Condition

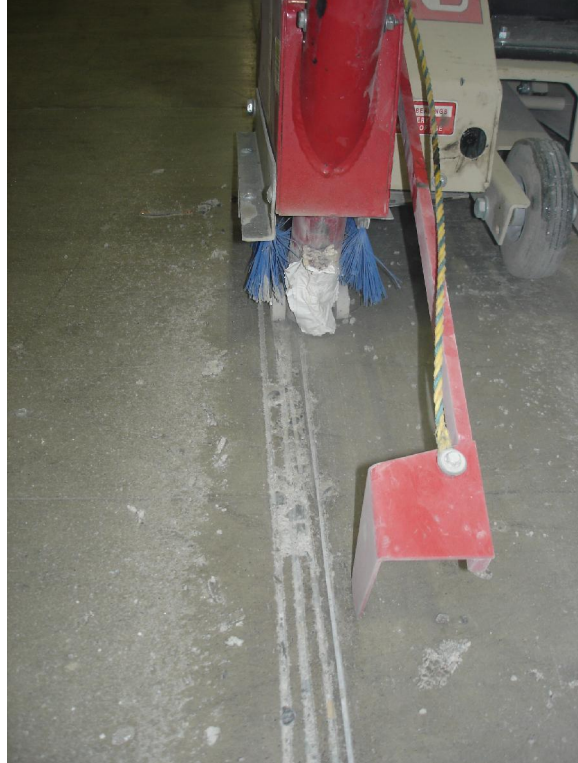
Saw Cut Lines Behind Spall

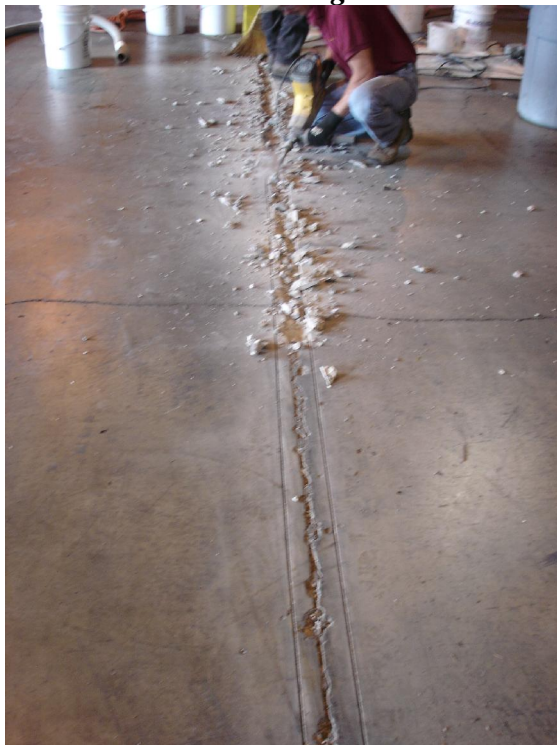
Remove Remaining Concrete

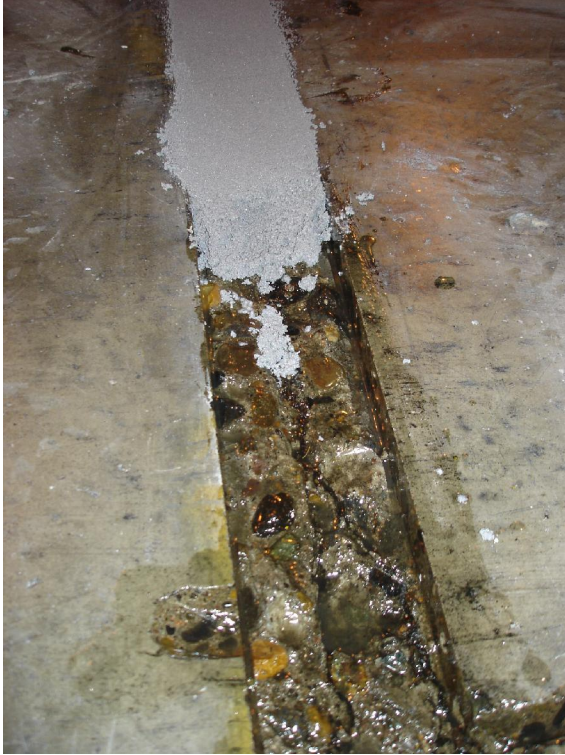
Fill Joint with Armor-Hard Mortar

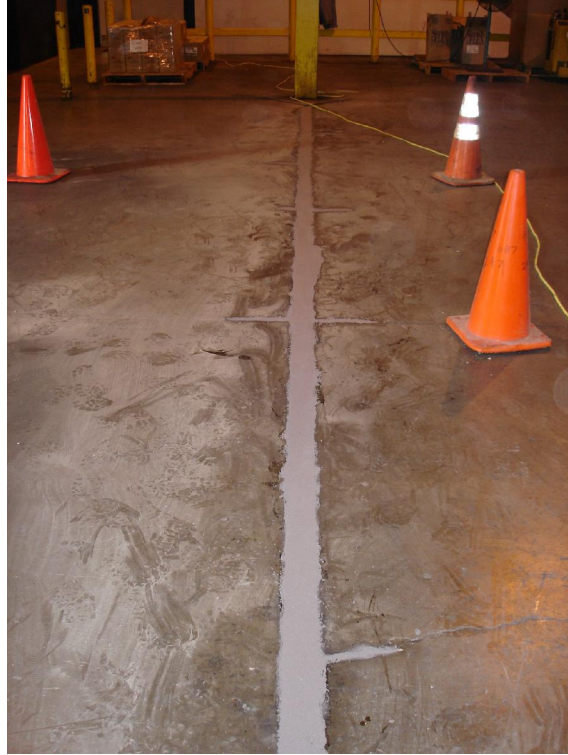
Trowel Mortar Flush with Floor

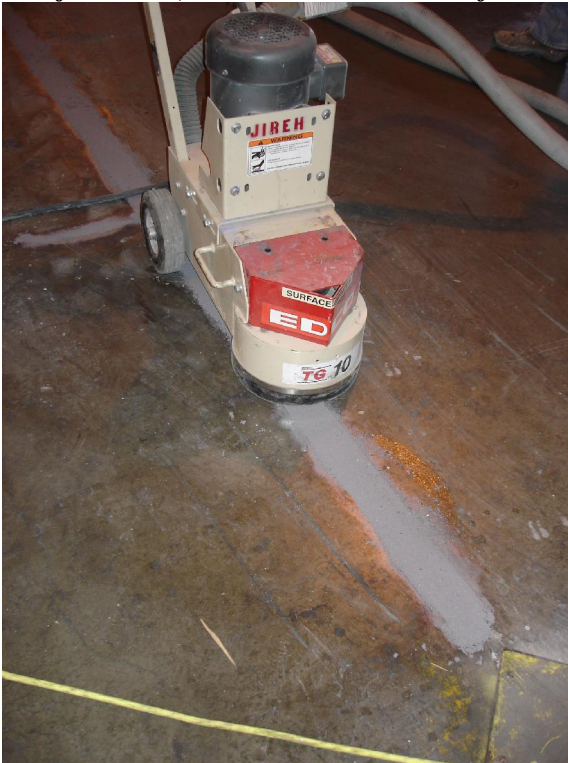
After Cure, Grind Flush with Surface

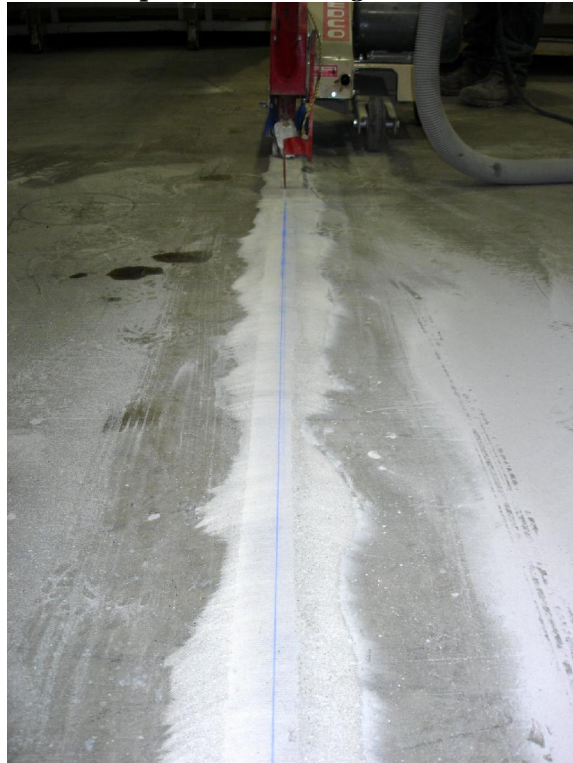
Snap Line Over Original Joint

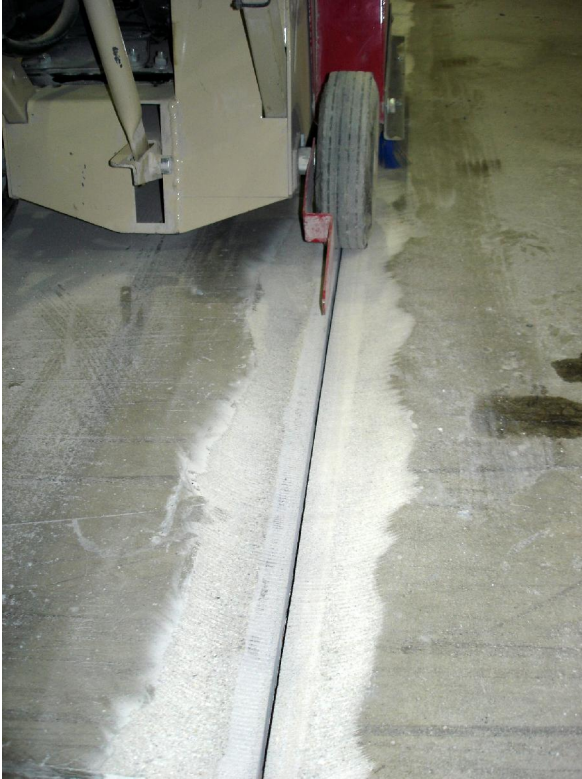
Saw Cut New Joint

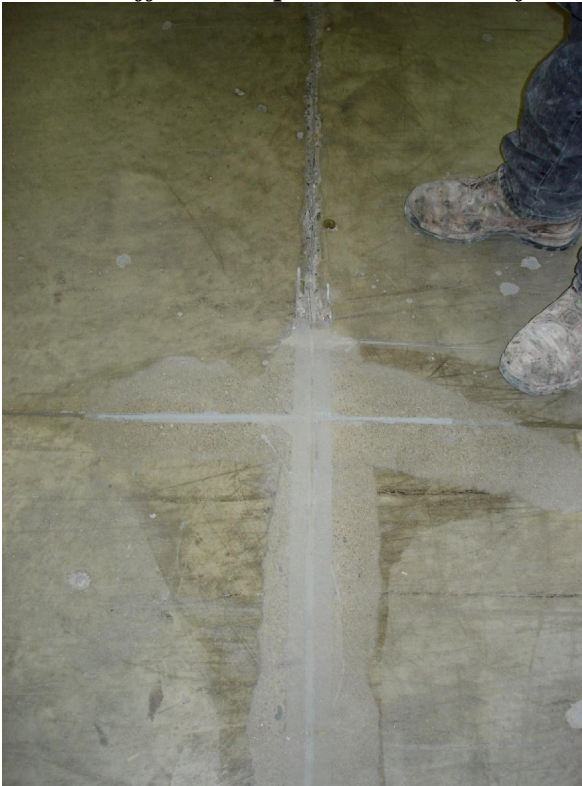
Razor Off Cured Spal-Pro 2000 Overfill

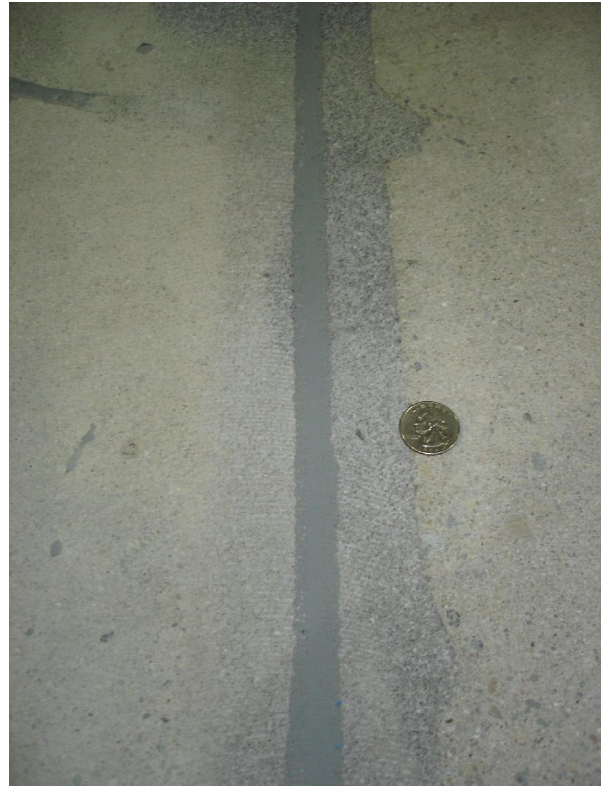
Restored Joint Condition
