JOINT FILLER SEPARATION - Minor to Severe

Option 1 - Refilling Voids Without Removal of Existing Filler

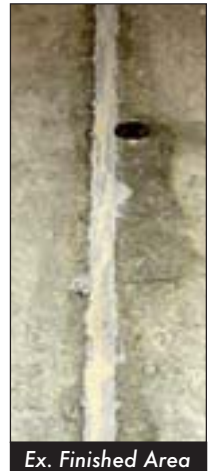
STEP 2

Overfill voids with appropriate semi-rigid filler. Monitor carefully as voids will likely require refilling as filler settles and trapped air is released. Allow filler to cure, then razor flush.
