Industrial Concrete Floor Joint and Surface Condition Monitoring and Maintenance

By Scott Metzger, Metzger/McGuire Co.

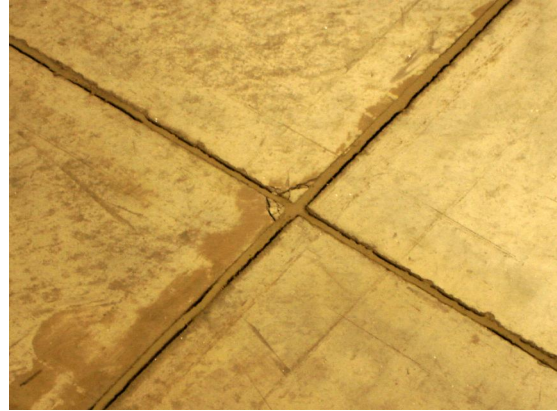
As with any building component, industrial floor joint filler may require periodic maintenance to ensure optimal performance. Joint edge damage (spalling) can result from lack of attention and proper maintenance.

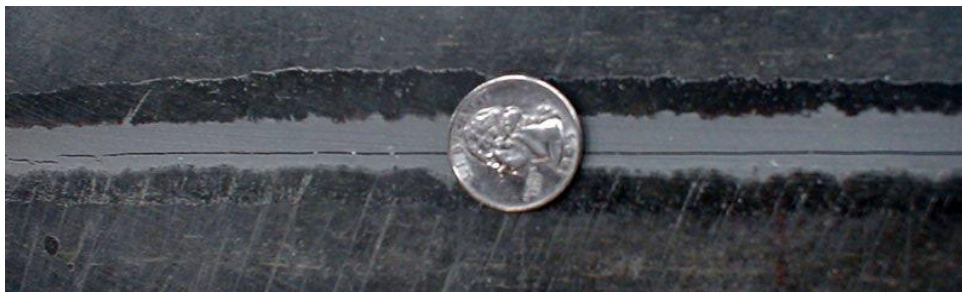
Early, Minor Separation Void – No maintenance generally required

Separation voids will generally first be seen as dark hairlines within material or along joint edges. Voids are usually not a concern to the structural integrity of the filler and its ability to protect unless they open to a width of 1/32” (credit card width) or greater. Even when voids do occur to this extent, potential exposure to joint edge damage will be dependent largely on the location and pattern of the voids. Internal separation (tears within filler) require less maintenance as they do not lead to joint edge exposure. Separation voids which jump back and forth across the joint or occur dominantly along one edge may require refilling if they exceed credit card or if there is evidence of joint edge deterioration/breakdown occurring at void locations.

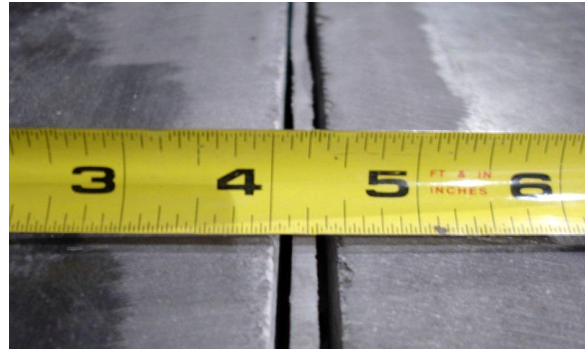
Right: Example of filler collapse in joint experiencing substantial opening...

Sections of joint filler which experience complete adhesion loss in the presence of substantial joint dimension opening can be “punched down” below the joint edge, exposing edges to impact. This would normally only occur in the presence of extreme joint opening (i.e. joint opens wide enough for filler to be driven below base of saw cut) or if there were underlying deficiencies in the original filler installation (i.e. shallow joint filler depth, placement over compressible foam rods or debris, inadequate joint preparation/cleaning, etc). Procedures for repairing depressed filler can be found under Concave/Low Filler Profile in M/M’s Guide to Basic Floor Repair.

Typical repair of joints exhibiting filler collapse involves removing existing filler, re-chasing or saw cutting joint to establish clean, structurally sound edges, and refilling the joint with a semi-rigid epoxy (ambient temperatures) or semi-rigid polyurea (freezer/cooler rooms or for faster access). If deteriorated joint width exceeds 1 ½” (38 mm) structural rebuilding of concrete edges may be desirable for optimal long term durability.

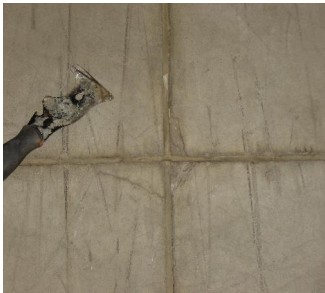
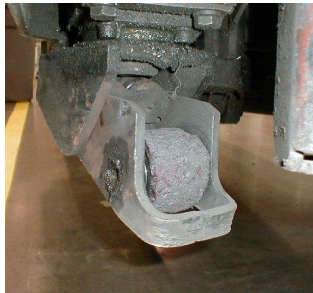
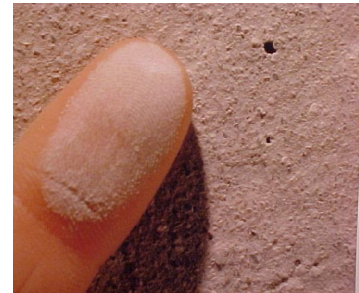
Above: Photo to left shows joint spalling and gouges possibly resulting from dragging of hard objects. Photo in middle shows excessive wheel wear, generally a result of poor floor maintenance and cleaning procedures or floor surface defects impacting wheel. Photo at right shows dusting, generally a result of original finishing practices or excessive surface wear.
