Industrial Concrete Floor Joint and Surface Condition Monitoring and Maintenance

By Scott Metzger, Metzger/McGuire Co.

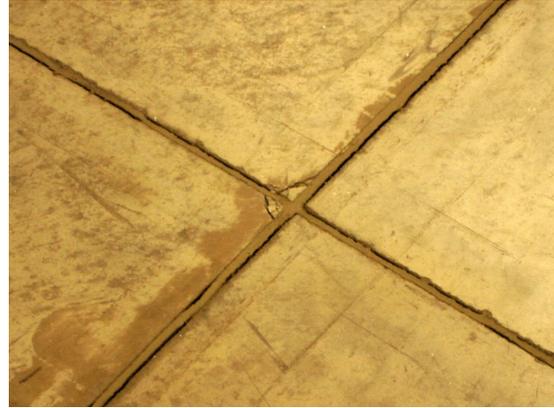
As with any building component, industrial floor joint filler may require periodic maintenance to ensure optimal performance. Joint edge damage (spalling) can result from lack of attention and proper maintenance.

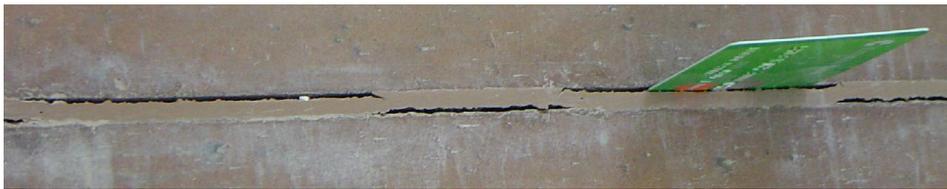
Separation Void at Credit Card Width 1/32” + Maintenance Suggested

Separation voids will generally first be seen as dark hairlines within material or along joint edges. Voids are usually not a concern to the structural integrity of the filler and its ability to protect unless they open to a width of 1/32” (credit card width) or greater. Even when voids do occur to this extent, potential exposure to joint edge damage will be dependent largely on the location and pattern of the voids. Internal separation (tears within filler) require less maintenance as they do not lead to joint edge exposure. Separation voids which jump back and forth across the joint or occur dominantly along one edge may require refilling if they exceed credit card or if there is evidence of joint edge deterioration/breakdown occurring at void locations.

If evidence of edge deterioration is present, voids should be cleaned and filled with a semi-rigid polyurea filler. Voids showing no evidence of compromising joint edge integrity should be monitored monthly to determine overall activity over a period of time. If voids remain at consistent width over the period of 6 months, refilling activity can be considered. But it is more likely that void dimension will open and close seasonally to some degree. If no signs of joint edge deterioration are present sanitation issues are not a concern filler separation voids generally will not require maintenance. If either concern is present, refill the voids.

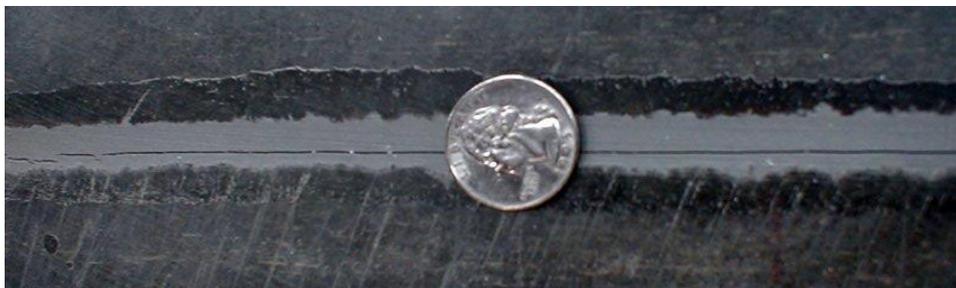
Early, Minor Separation Void – No maintenance generally required

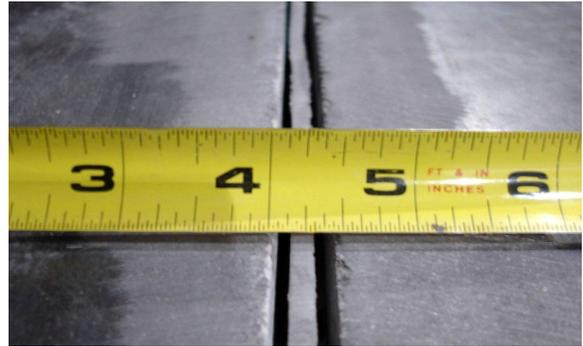
Right: Example of filler collapse in joint experiencing substantial opening...

Sections of joint filler which experience complete adhesion loss in the presence of substantial joint dimension opening can be “punched down” below the joint edge, exposing edges to impact. This would normally only occur in the presence of extreme joint opening (i.e. joint opens wide enough for filler to be driven below base of saw cut) or if there were underlying deficiencies in the original filler installation (i.e. shallow joint filler depth, placement over compressible foam rods or debris, inadequate joint preparation/cleaning, etc). Procedures for repairing depressed filler can be found under Concave/Low Filler Profile in M/M’s Guide to Basic Floor Repair.

Joints exhibiting truly depressed filler should be easily identifiable as joint edge deterioration will likely be noted in any area where the filler has dropped in profile, substantially exposing joint edges to impact/damage. If facility

Typical repair of joints exhibiting filler collapse involves removing existing filler, re-chasing or saw cutting joint to establish clean, structurally sound edges, and refilling the joint with a semi-rigid epoxy (ambient temperatures) or semi-rigid polyurea (freezer/cooler rooms or for faster access). If deteriorated joint width exceeds 1 ½” (38 mm) structural rebuilding of concrete edges may be desirable for optimal long term durability.

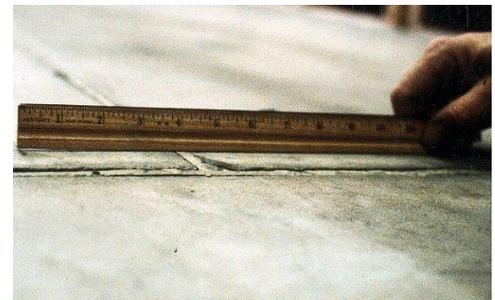
Right: Example of slab edge curl...

Joint edge curling is readily identifiable by a difference in joint edge elevation across any given joint. Slab edge curl is inevitable to some degree on virtually every industrial floor. While the causes of curl are many and still the source of much disagreement within the industry, in very basic terms edge curl occurs as a result of slab panel edges or ends drying faster than the center of the slab panel, leading to a curling or warping effect similar to the behavior exhibited by a wet sponge left to dry out.

Depending upon the degree of curl, it may not present any problem at all or it may be a condition requiring corrective action. Slab edge curl warranting assessment and potential corrective action should be evident as the joint edge will begin to exhibit spalling/deterioration under material handling vehicle traffic (the higher joint edge being impacted and chipped away). In our experience, generally this condition is identified shortly after the floor is placed and is not as likely to occur in areas where it was not previously identified within the first 6 months in the life of the floor. If slab curl condition is present to the degree that it is impacting material handling operations, leading to joint deterioration, or if panels show evidence of “rocking” as vehicles cross the joint, it is important to bring in an engineer, consultant or trusted industrial floor resource to determine potential need for correction and the best long term correction options.

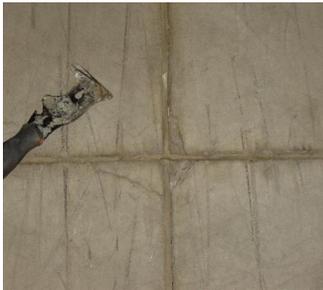
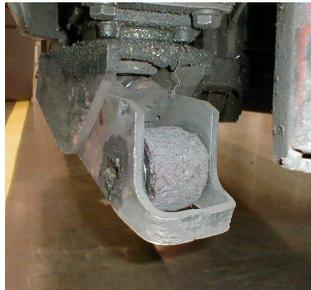
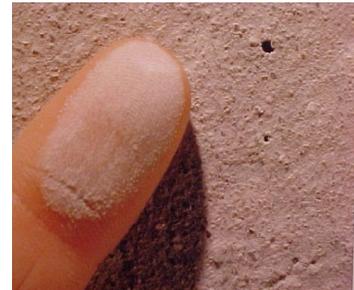
Above: Photo to left shows joint spalling and gouges possibly resulting from dragging of hard objects. Photo in middle shows excessive wheel wear, generally a result of poor floor maintenance and cleaning procedures or floor surface defects impacting wheel. Photo at right shows dusting, generally a result of original finishing practices or excessive surface wear.

Potential surface deterioration issues should be readily identifiable visually, the most likely being scratches, gouges, etc. A vast majority of surface defects result from abuse directly related to material handling vehicles and material handling practices. Scratches and gouges often result from inadequate cleaning of the floor and the subsequent friction resulting from debris, wood slivers from pallets, nails, etc being dragged under the wheel of a material handling vehicle across the floor. Improper driver material handling practices such as pallet dragging, pallet pushing, driving with forks dropped, dropping loads too quickly, etc. are all the most likely contributors and causes to any floor surface defects which might become visible. If signs of substantial or abusive surface wear, our recommended first step is to work with the material handling vehicle operators to identify the practices leading to the deterioration and work to change the practices suspected as the most likely cause.

- Signs of spalling, chipping or other deterioration
- Signs or evidence of dusting or gradual erosion of surface
- Any defect/deterioration areas where impact can be felt by MHV operators
- Areas exhibiting wear/damage that appears to be unusual or develops/changes rapidly
